Roadway Condition Report *Route 17 In Sullivan County*

MEMORANDUM
DEPARTMENT OF TRANSPORTATION

SUBJECT ROADWAY CONDITION REPORT
ROUTE 17 IN ~~SULLIVAN~~ COUNTY
BROOME

TABLE OF CONTENTS

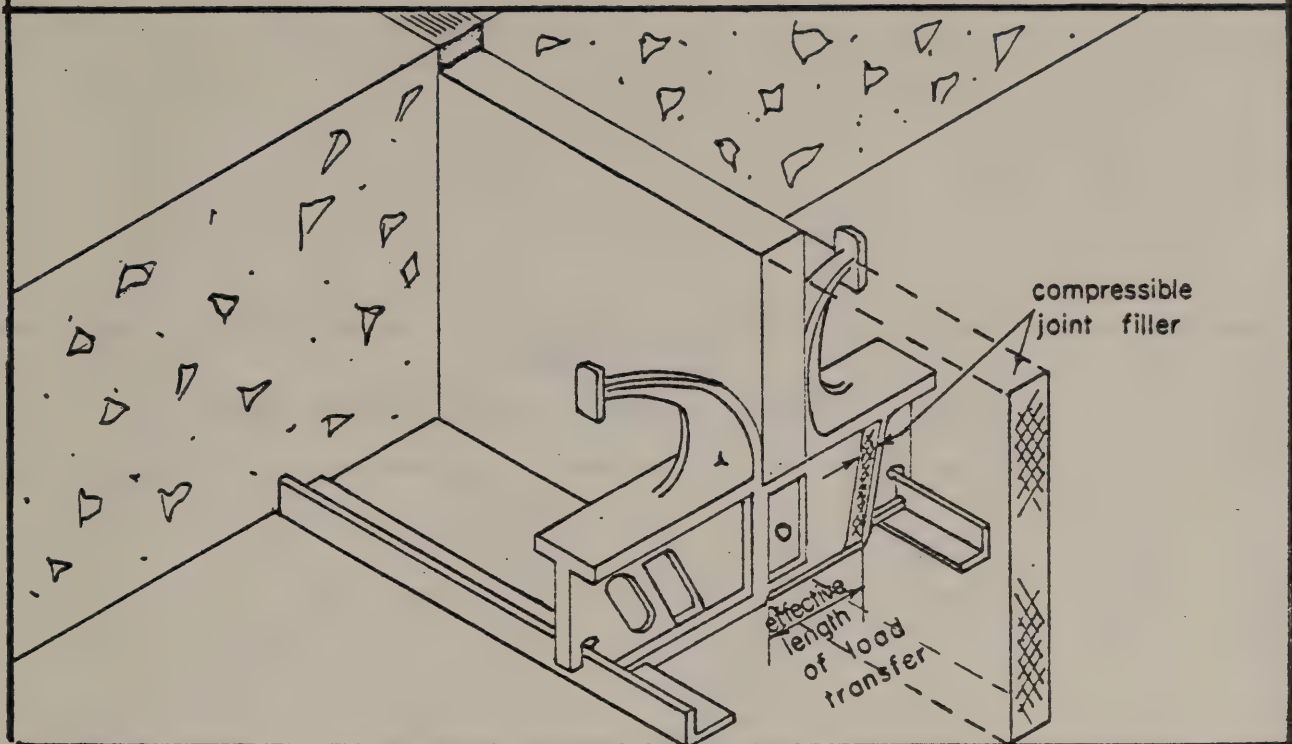
Figure No.6
TWO-PIECE MALLEABLE IRON SLEEVE

A core taken in the area of the Shawangunk Mountains shows a different transverse joint load transfer device than that found in other contracts. It is similar to Figure No. 6, a Two-Piece Malleable Iron Sleeve, noted in Physical Research Report 66-2. See Page 25. This joint device and other factors have given good service in this particular area. However, some minor faulting can still be attributed to this style of joint in other areas of the contract.
